TECHNICAL MEMORANDUM

Subject: Evapotranspiration Cover Performance Expectations Technical Memorandum, McCormick & Baxter Superfund Site, Portland, Oregon, Task Order No. 71-03-12-01, E & E Project No. 0016688.OY12.14.03

50% Design Report for an Evapotranspiration Cover at the McCormick and Baxter Superfund Site, Portland, Oregon

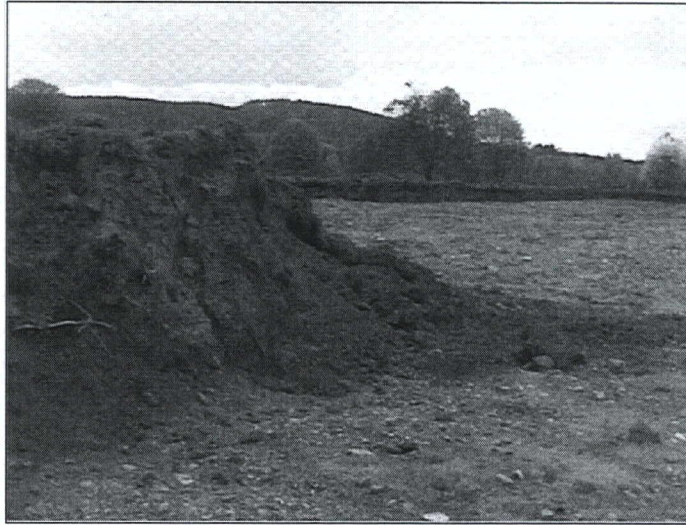
Figure 1. A potential topsoil source available from St. Helens, Oregon

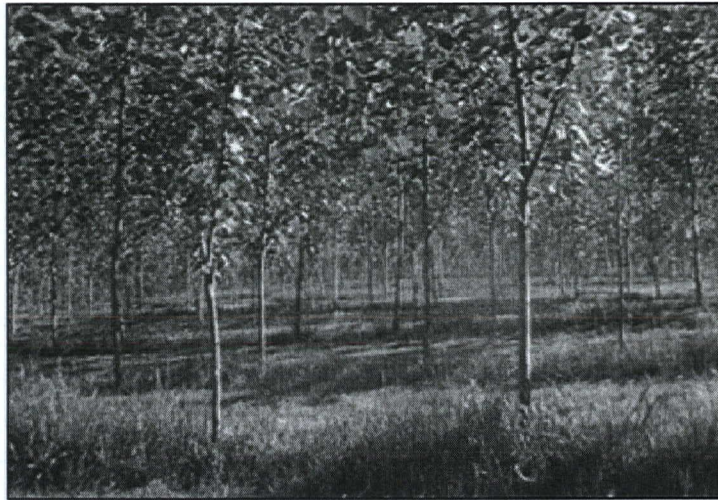
Figure 3. Three years after installing an ECap[™] at the Duvall Custodial Landfill

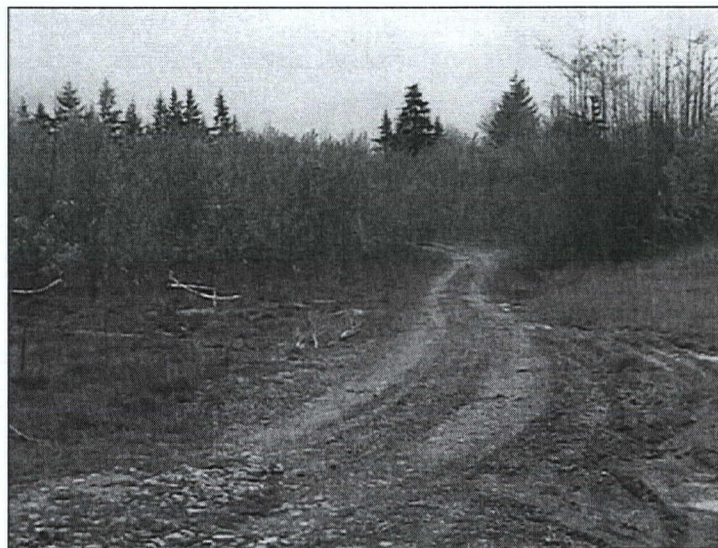
Figure 4. Four years after installing an ECap[™] at the Duvall Custodial Landfill. Hydraulic data monitored at this site has been used to estimate the poplar crop coefficient, determine root depth influence on water uptake, and to evaluate the complete water balance.

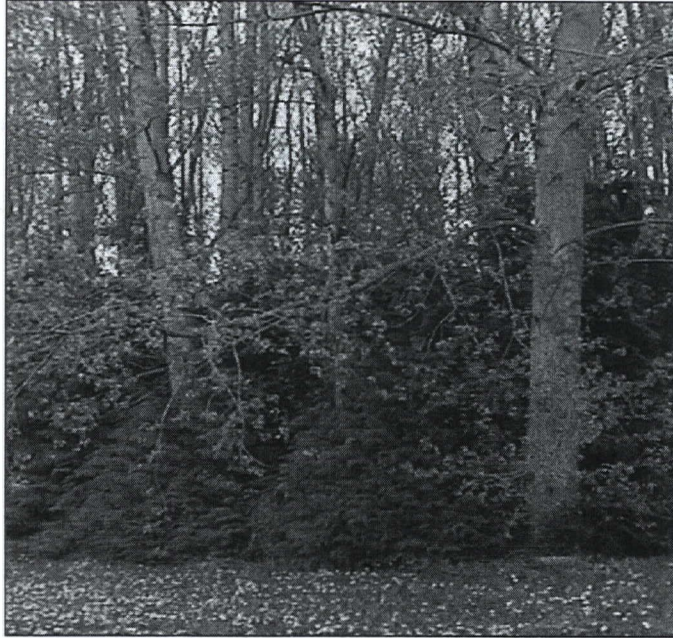
Figure 5. 25 years after interplanting hybrid poplar and western red cedar at a Washington State University research farm near Puyallup, Washington
